Load Testing – Theatre Lighting Rig

116 Bank Street, Whangarei.

For *OneOneSix Trust*

CC Project Number: 16211

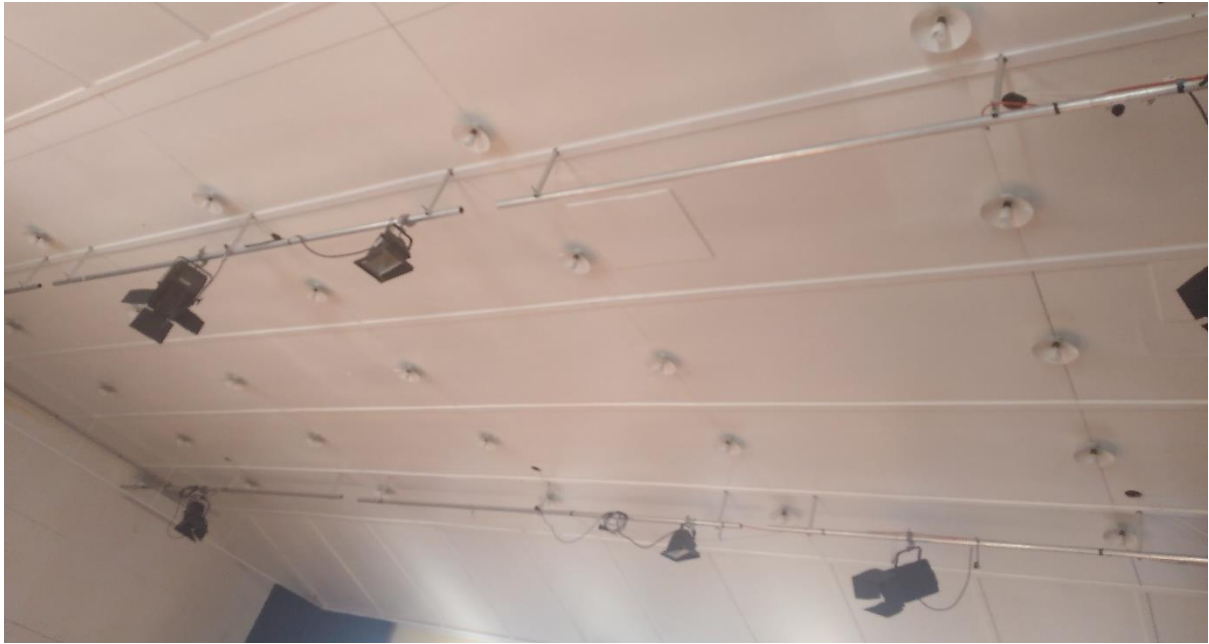
Aluminum scaffold-bars are suspended approximately 300mm below ceiling height. Each bar has three supporting struts.

Photo showing lighting rigs.

These are suspended using three 25mm SHS Aluminum members, connected to rafters with M8 bolts.

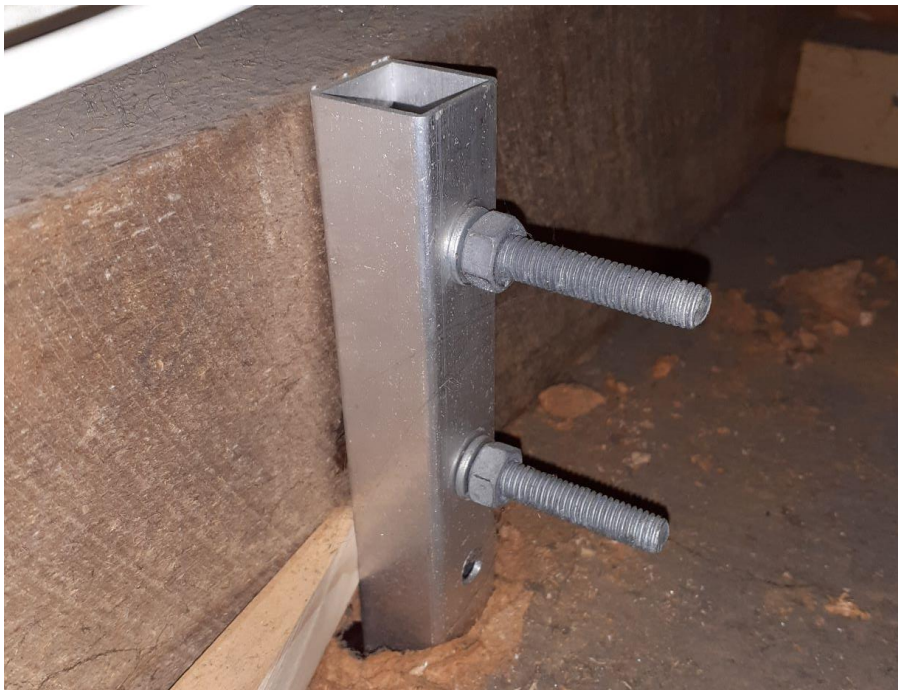
Photo of strut to rafter connection.

Loads should be removed after use to avoid sagging of timber rafters through long-term creep and to avoid undo stress from potential earthquake action.
